Metropolitan Atlanta Performance Home Inspection Report

**Property Address:
2900 Delray Drive**

**Date:
August 30, 2015**

This 1960 framed cottage has been renovated

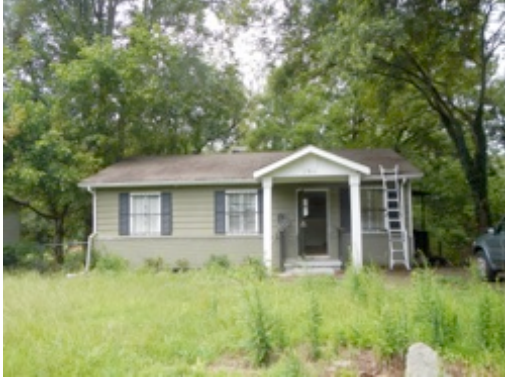
Porch added. Not centered on front door

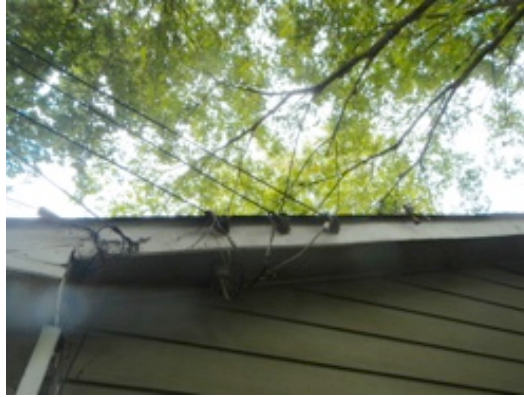
Cover exposed energized conductor connections

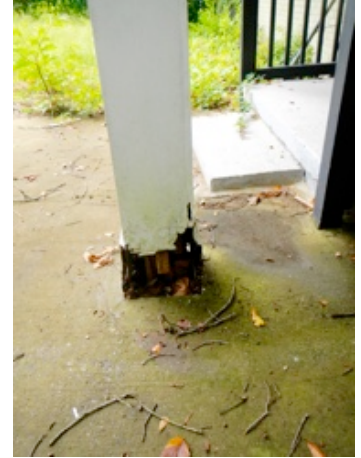
Repair post rot. Concrete poured over/around post base

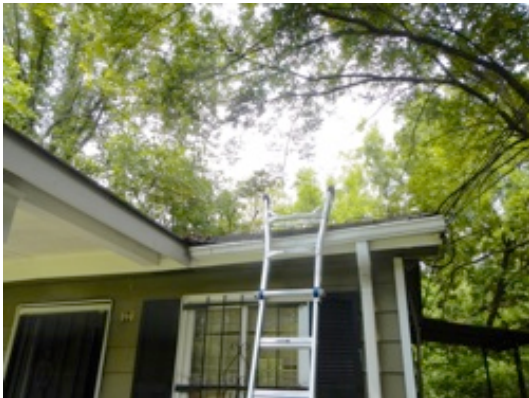
Incomplete and leaking gutter a cause of wood damage at front right corner

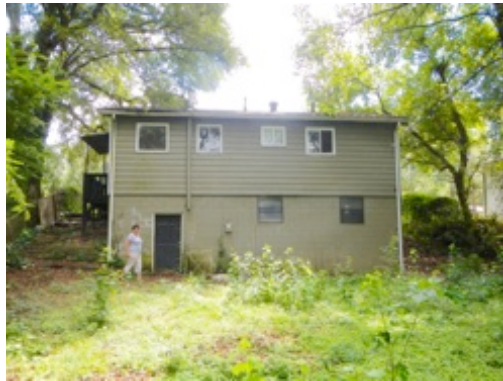
Fouled gutter leaking at basement entry. Nearby downspout a source of basement moisture

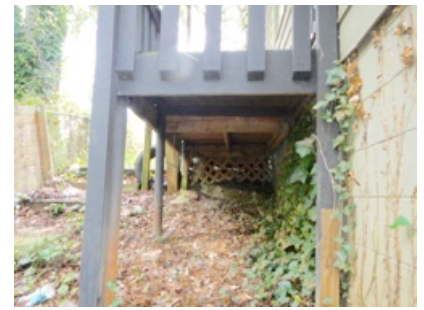
Side deck not supported in a workmanlike fashion

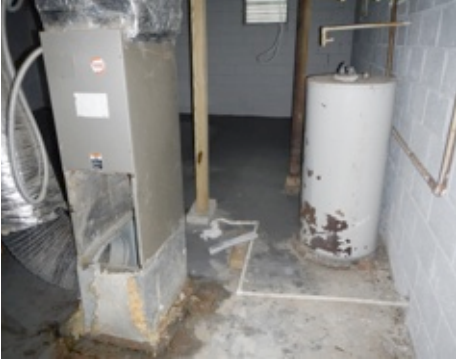
Derelict heat pump and water heater

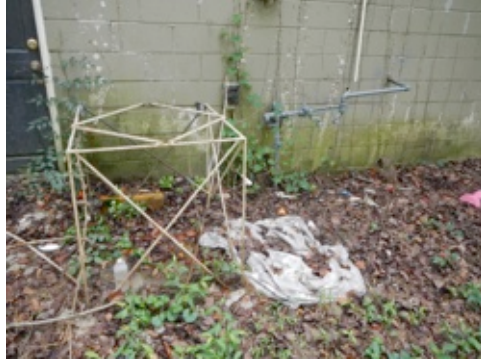
Outside unit stolen

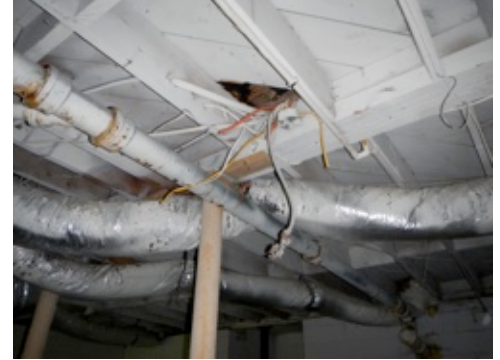
Wiring cut and stolen

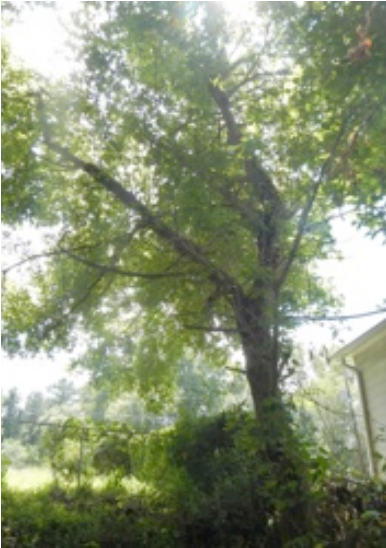
Remove invasive tree at left side

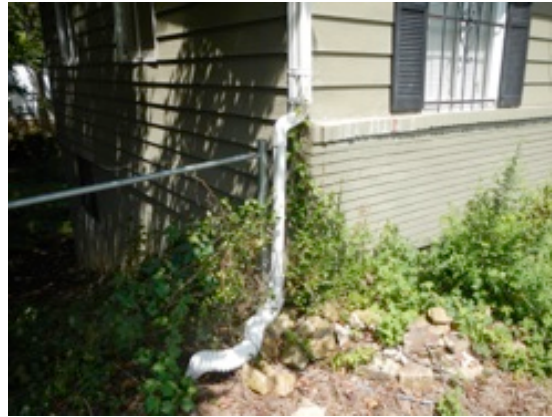
History of wood rot and termites due to roof water. Top row of brick slopes towards house and feeds water into wall

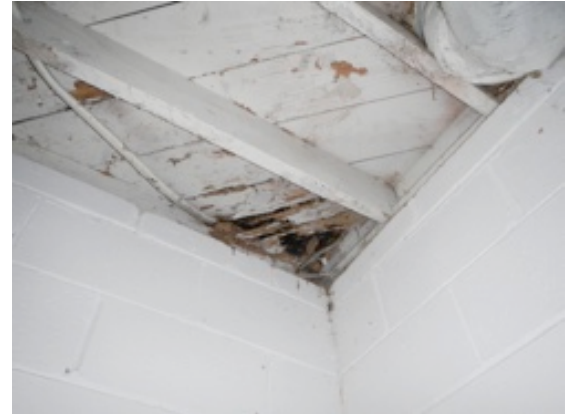
Repair rot and termite damage at front right corner. Raised concrete is one cause of damage

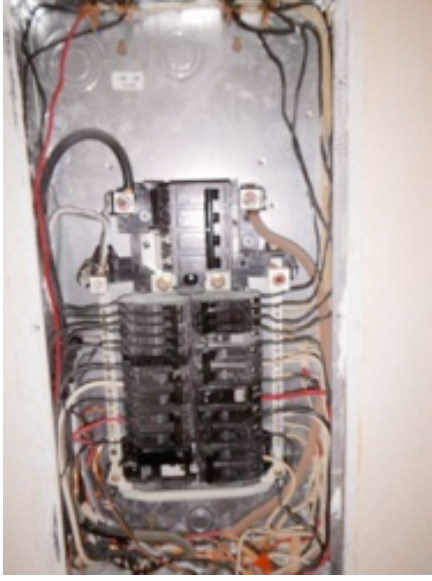
Electric panel at maximum due to all-electric home

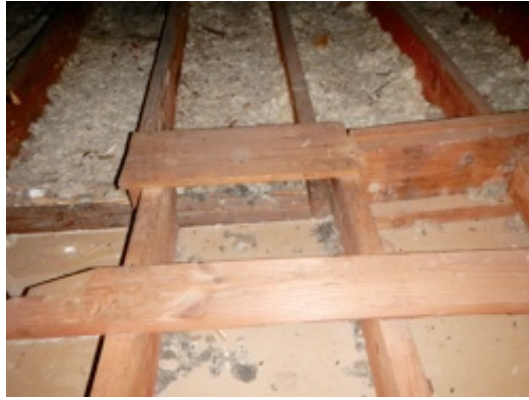
Wall at kitchen dropped due to inadequate support. Ceiling insulation damaged throughout due to rodent activity. No rafter bracing struts (knee braces) at right side attic

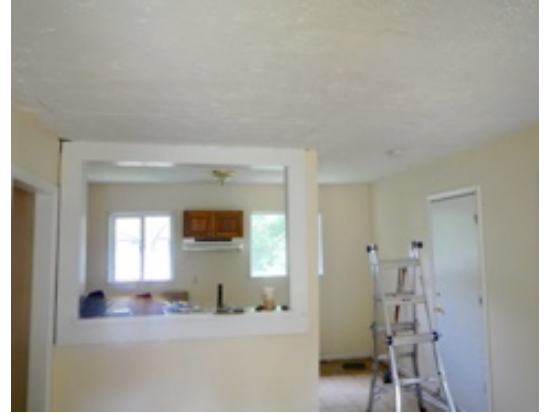
Wall and living room/dining room ceiling dropped due to inadequate framing support

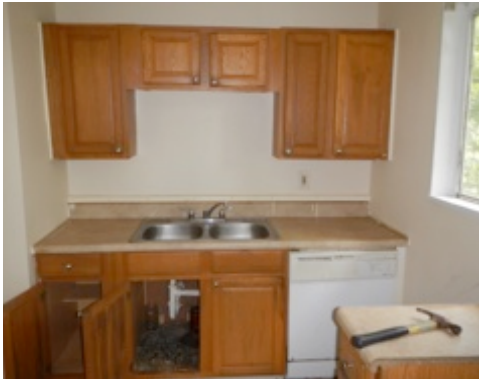
More countertop receptacles needed. Receptacles should be groundfault protected. Functional kitchen design is needed

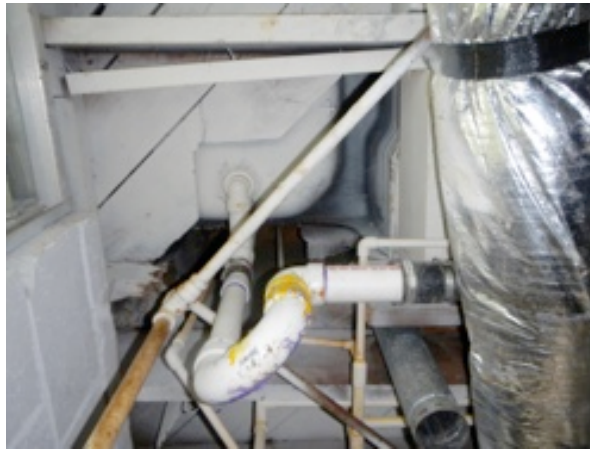
Floor framing below bathroom is not workmanlike and does not meet industry standards: correction required

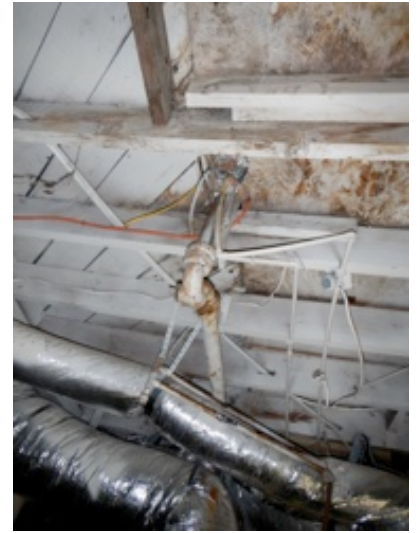
Require structural support at point load at kitchen wall, near where old drain was not removed

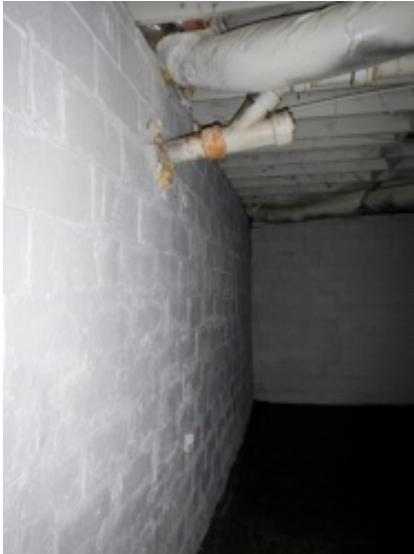
Front wall bowed due to soil and moisture loads. Wall under-designed. Require reduce moisture at center front outside wall

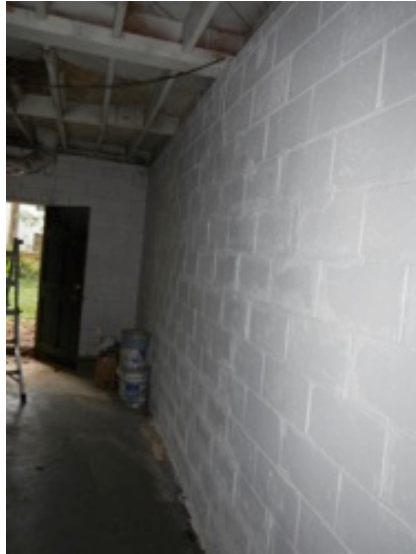
Right and left sidewalls bowed to a lesser extent. Reduce moisture loads

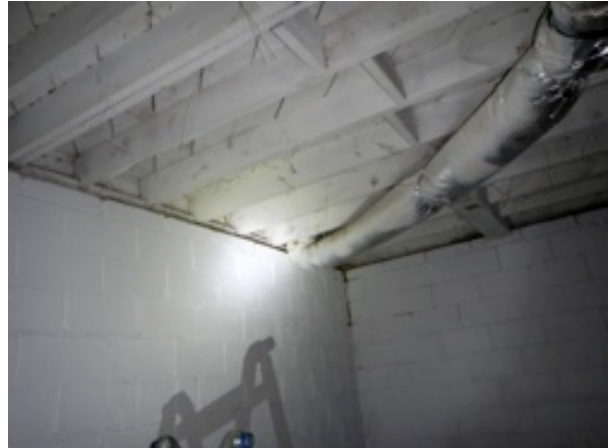
Repair or support termite-damaged band joist about 8ft along front wall

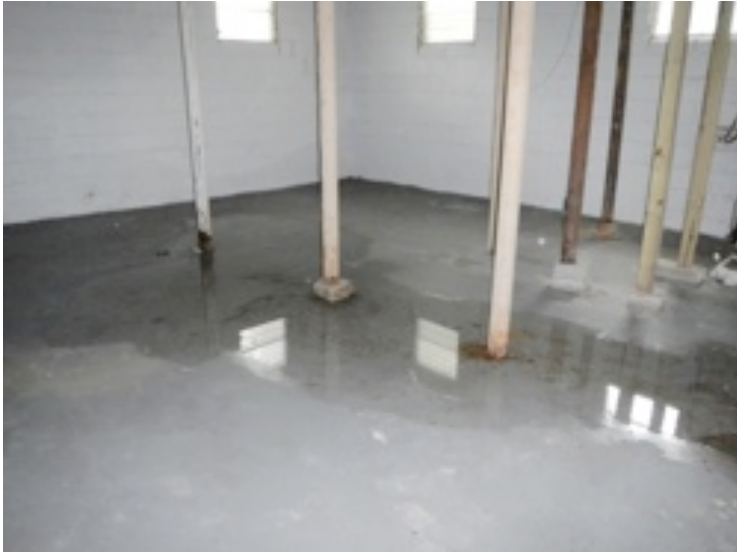
Slab has settled under structural (column/interior) load. Water an indication of load path. Sounding indicates THIS SECTION of slab in contact with soil

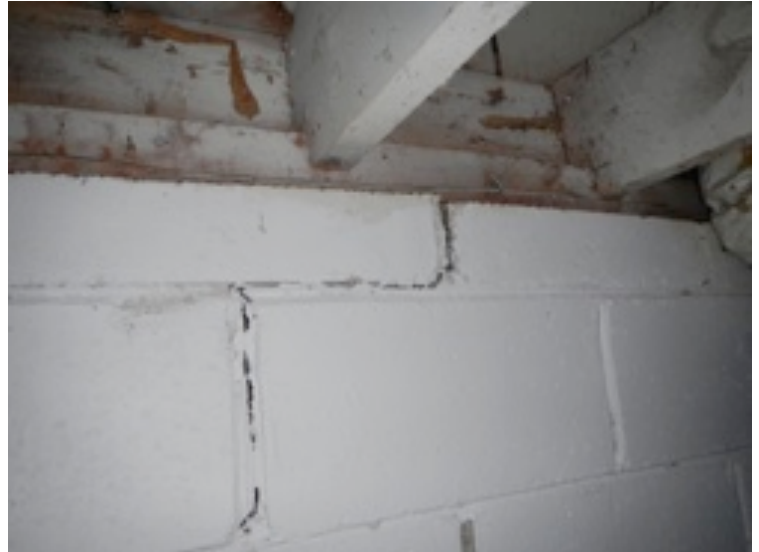
Detail at front left corner. There is a history of wood damage and wall cracks
